Manhole Inspection Summary

Manhole # **S13AA1011MH**

Insp Date: **6/30/09 10:57 AM**

Location Address: **3003 SPRINGHILL AVE**

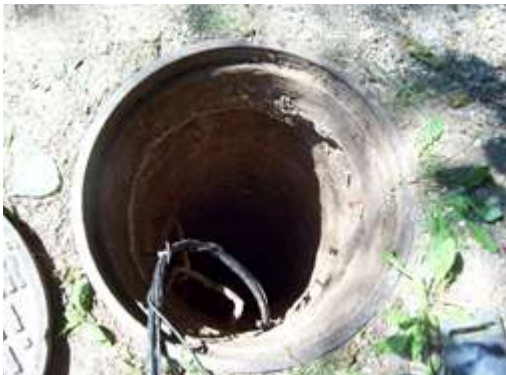
Defect 1

Offset: **0.5** (in.)

frame offset

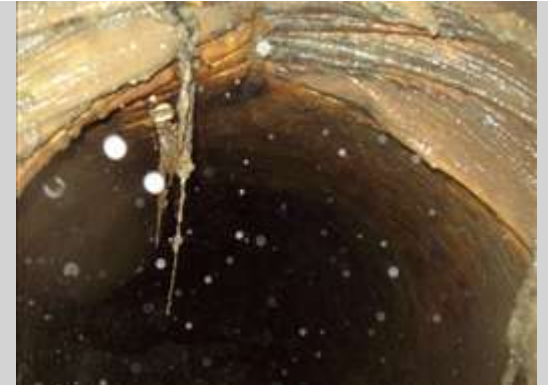
12 O'Clock Outflow

21 in. Circular Gravity Sewer
Pipe Out @ 12 O'Clock

Pipe Height: (in.) Direct
Pipe Material: **Clay** ☐ Pipe Lined
Invert Depth: **25.80** (ft.) Flow Characteristics: **Fast**
Deposits: ☒ None ☐ Mud ☐ Sludge ☐ Debris ☐ Grease
Silt Depth: (in.) Deposits Extent:
Infiltration: **None** Pipe Seal Cond: **Sound**

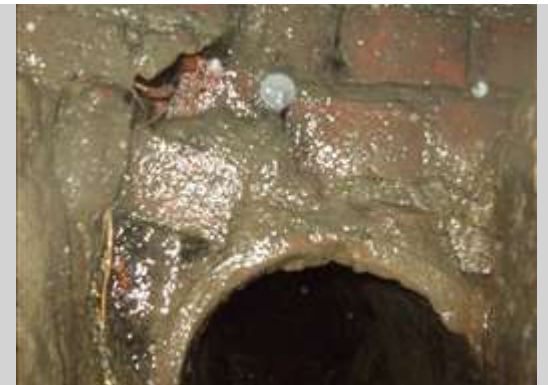
3 O'Clock Inflow

8 in. Circular Gravity Sewer
Pipe In @ 3 O'Clock

Pipe Height: (in.) Direct
Pipe Material: **Clay** ☐ Pipe Lined
Invert Depth: **25.20** (ft.) Flow Characteristics: **Fast**
Deposits: ☒ None ☐ Mud ☐ Sludge ☐ Debris ☐ Grease
Silt Depth: (in.) Deposits Extent:
Infiltration: **None** Pipe Seal Cond: **Sound**

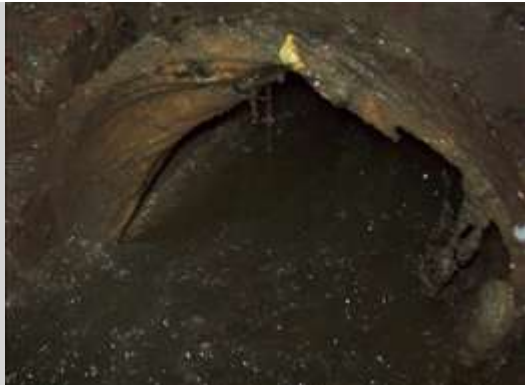
6 O'Clock Inflow

Pipe In @ 6 O'Clock

Invert Depth: **25.76** (ft.) Flow Characteristics: **Fast**

Infiltration: **None** Pipe Seal Cond: **Sound**

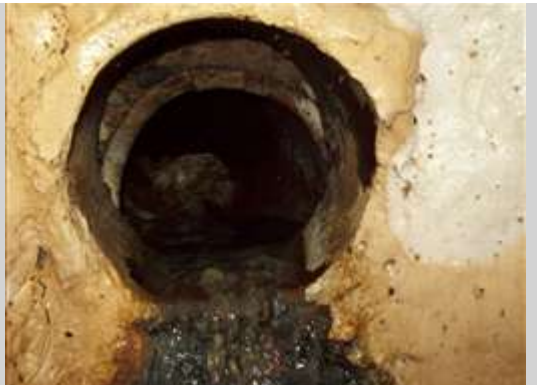
9 O'Clock Inflow

Pipe In @ 9 O'Clock

Invert Depth: **17.80** (ft.) Flow Characteristics: **Fast**

Infiltration: **None** Pipe Seal Cond: **Sound**

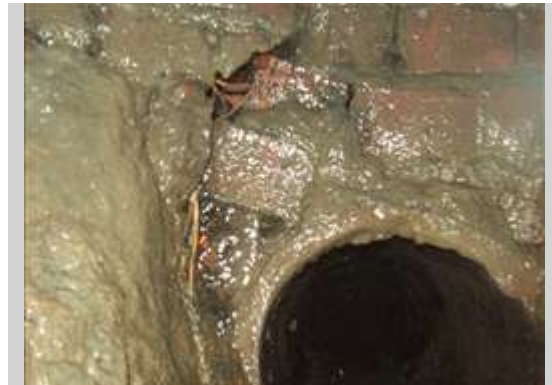
Drop In @ 9 O'Clock

Drop: **Inside** **Direct**

Inv Depth: **24.80** (ft.)

Drop Condition: **Open**
